**Flood Control Project Maintenance  
Levee Inspections**

**Fall 2010 Levee Maintenance Deficiency Summary Report**

**Levee District No. 0003 (Glenn County)**

**Levee Inspection Report By Mile - Fall 2010**

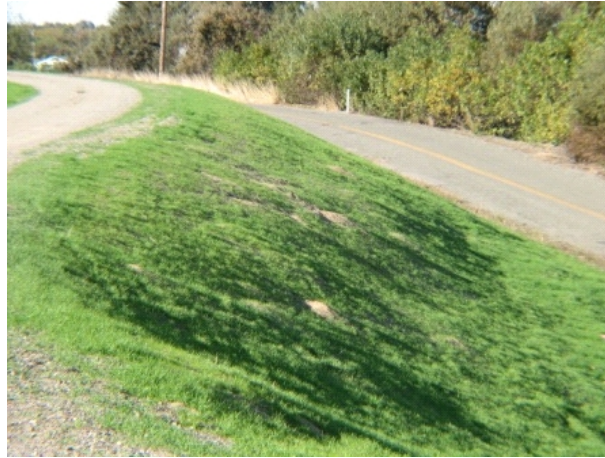
Levee Mile Report Line	1
Start Levee Mile	0.23
End Levee Mile	0.29
Location	Land Side
Category	Earthen Levee
Item	Animal Control

View of squirrel holes along the slope.

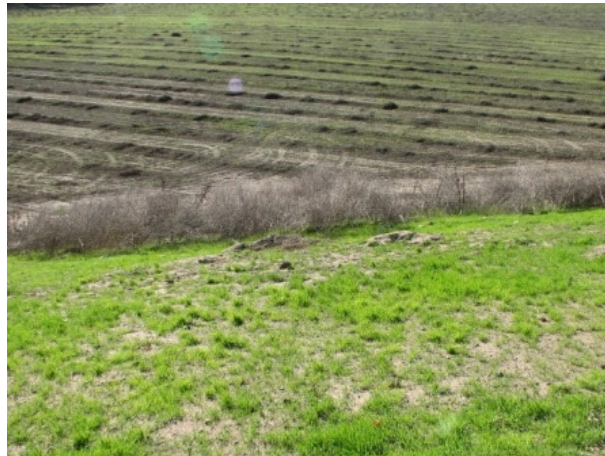
Levee Mile Report Line	2
Start Levee Mile	0.29
End Levee Mile	0.40
Location	Water Side
Category	Earthen Levee
Item	Animal Control

View of squirrel holes along the slope.

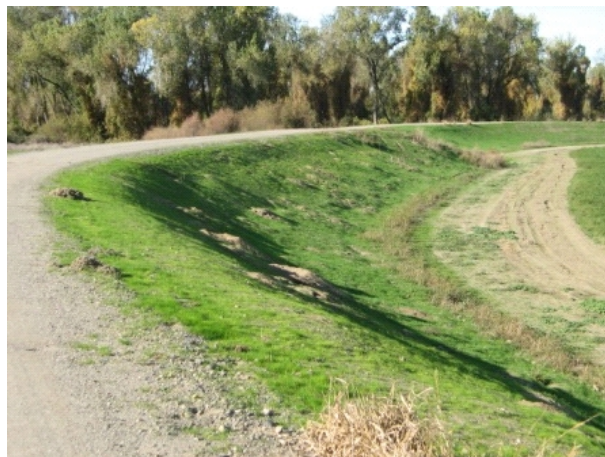
Levee Mile Report Line	4
Start Levee Mile	0.75
End Levee Mile	0.75
Location	Land Side
Category	Earthen Levee
Item	Animal Control

View of squirrel holes along the slope.

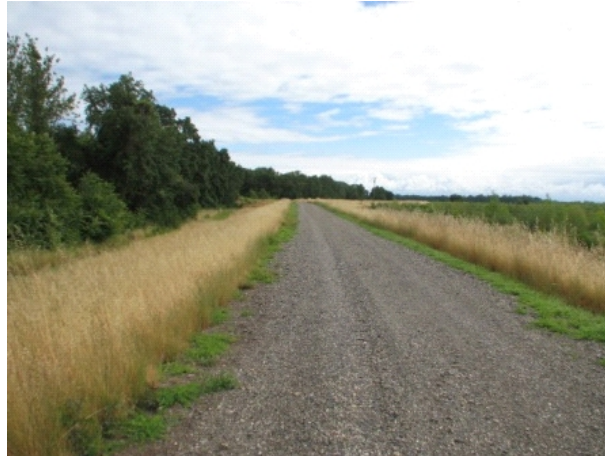
Levee Mile Report Line	6
Start Levee Mile	1.41
End Levee Mile	1.61
Location	Water Side
Category	Supplemental
Item	USACE Erosion Survey

Typical view of the grasses on the Levee.

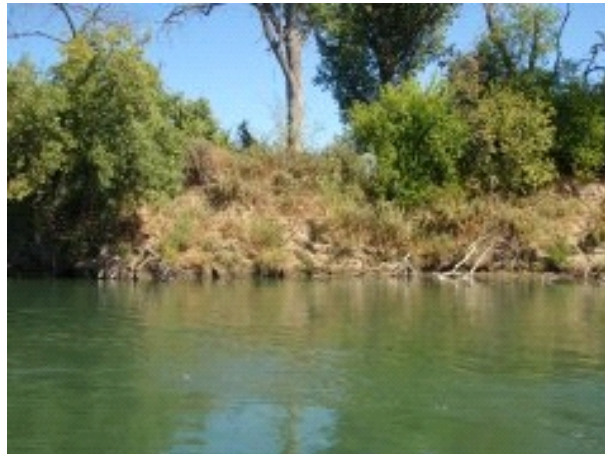
Levee Mile Report Line	6
Start Levee Mile	1.41
End Levee Mile	1.61
Location	Water Side
Category	Supplemental
Item	USACE Erosion Survey

2009: 15 ft berm, 1:1 slope, tree hazards and slumping, clays and silts, 10.07 ft/s [2009 SiteID:SAC\_163-0\_L]

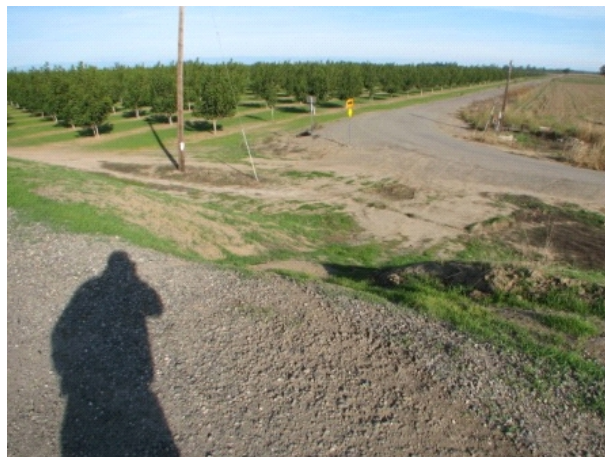
Levee Mile Report Line	11
Start Levee Mile	3.44
End Levee Mile	3.44
Location	Land Side
Category	Earthen Levee
Item	Slope Stability

View of the vehicle erosion on the landside slope of the levee.

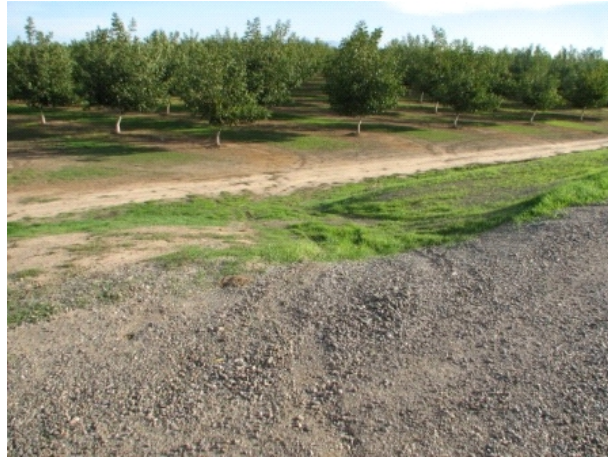
Levee Mile Report Line	15
Start Levee Mile	3.82
End Levee Mile	3.82
Location	Land Side
Category	Earthen Levee
Item	Slope Stability

View of vehicle erosion on the slope.

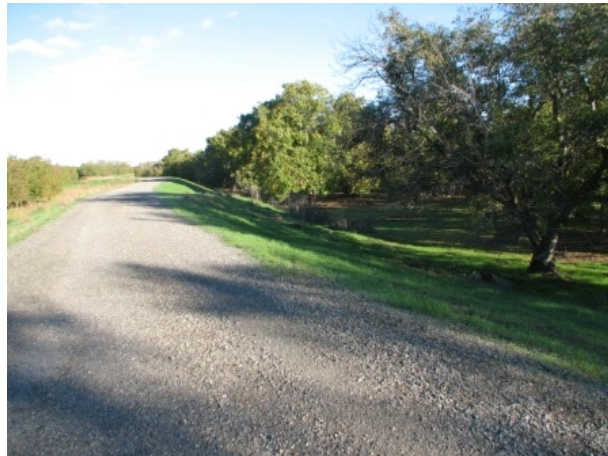
Levee Mile Report Line	17
Start Levee Mile	5.17
End Levee Mile	5.30
Location	Land Side
Category	Earthen Levee
Item	Trim / Thin Trees

View of squirrel along the slope.

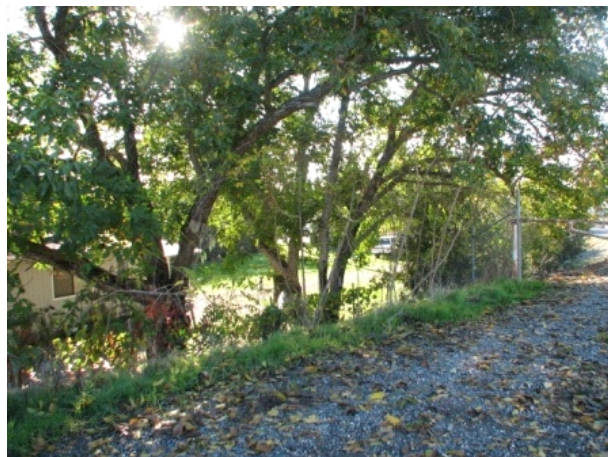
Levee Mile Report Line	24
Start Levee Mile	6.88
End Levee Mile	6.88
Location	Land Side
Category	Earthen Levee
Item	Trim / Thin Trees

View of the trees that are hanging over the landside slope of the levee.

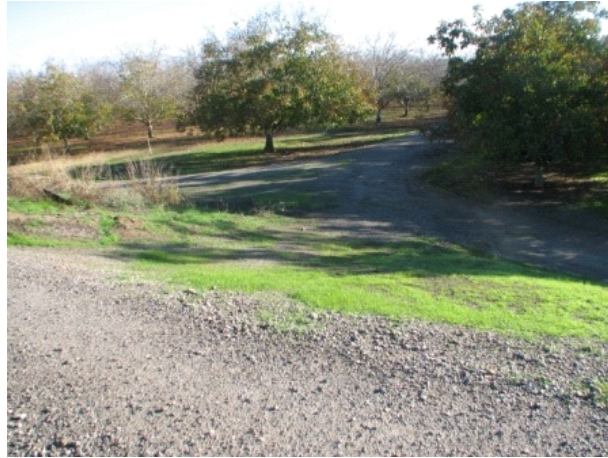
Levee Mile Report Line	26
Start Levee Mile	7.34
End Levee Mile	7.34
Location	Land Side
Category	Earthen Levee
Item	Slope Stability

Vehicle erosion along the slope.

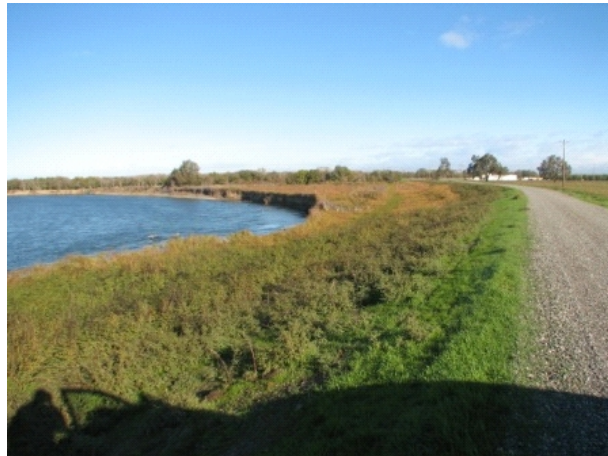
Levee Mile Report Line	29
Start Levee Mile	9.88
End Levee Mile	9.88
Location	Water Side
Category	Earthen Levee
Item	Erosion / Bank Caving

Erosion 30 ft from the levee toe.

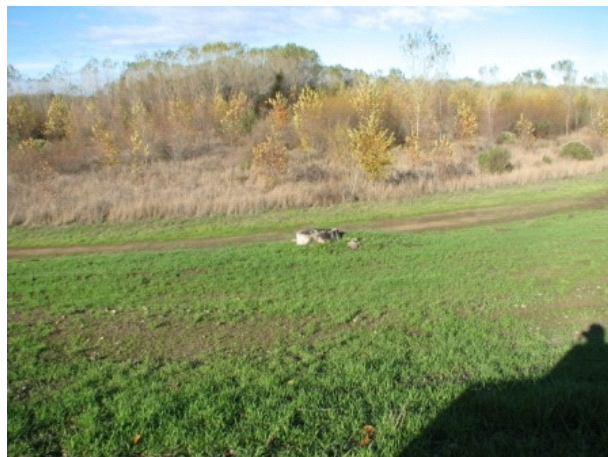
Levee Mile Report Line	31
Start Levee Mile	10.73
End Levee Mile	10.73
Location	Water Side
Category	Earthen Levee
Item	Trim / Thin Trees

view of the stump along the toe.

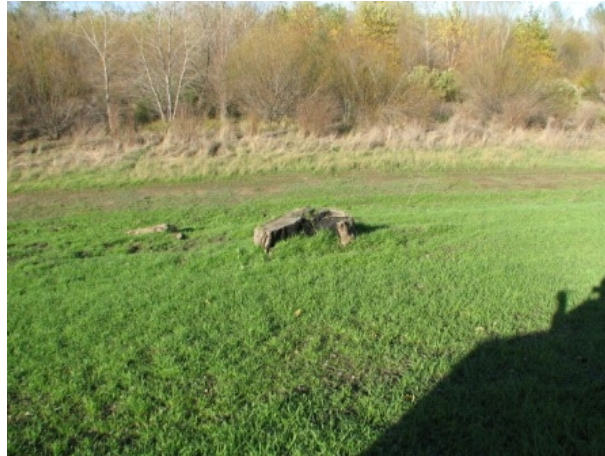
Levee Mile Report Line	32
Start Levee Mile	10.90
End Levee Mile	10.90
Location	Water Side
Category	Earthen Levee
Item	Trim / Thin Trees

View of the stump along the slope.

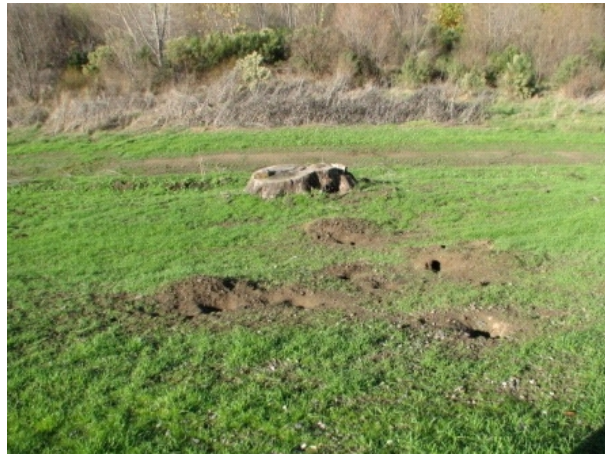
Levee Mile Report Line	33
Start Levee Mile	11.05
End Levee Mile	11.05
Location	Water Side
Category	Earthen Levee
Item	Animal Control

View of the squirrel holes along the slope & also a tree stump.

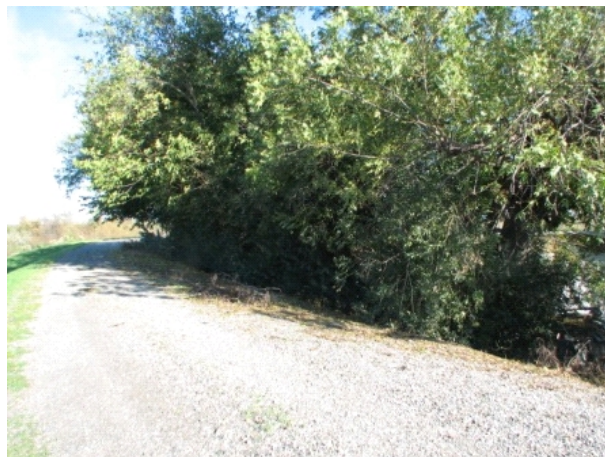
Levee Mile Report Line	34
Start Levee Mile	11.22
End Levee Mile	11.25
Location	Land Side
Category	Earthen Levee
Item	Trim / Thin Trees

View of the trees along the slope.
